RESOLUTION MSC.125(75)
(adopted on 24 May 2002)

**ADOPTION OF AMENDMENTS TO THE GUIDELINES ON THE ENHANCED
PROGRAMME OF INSPECTIONS DURING SURVEYS OF BULK CARRIERS AND
OIL TANKERS (RESOLUTION A.744(18), AS AMENDED)**

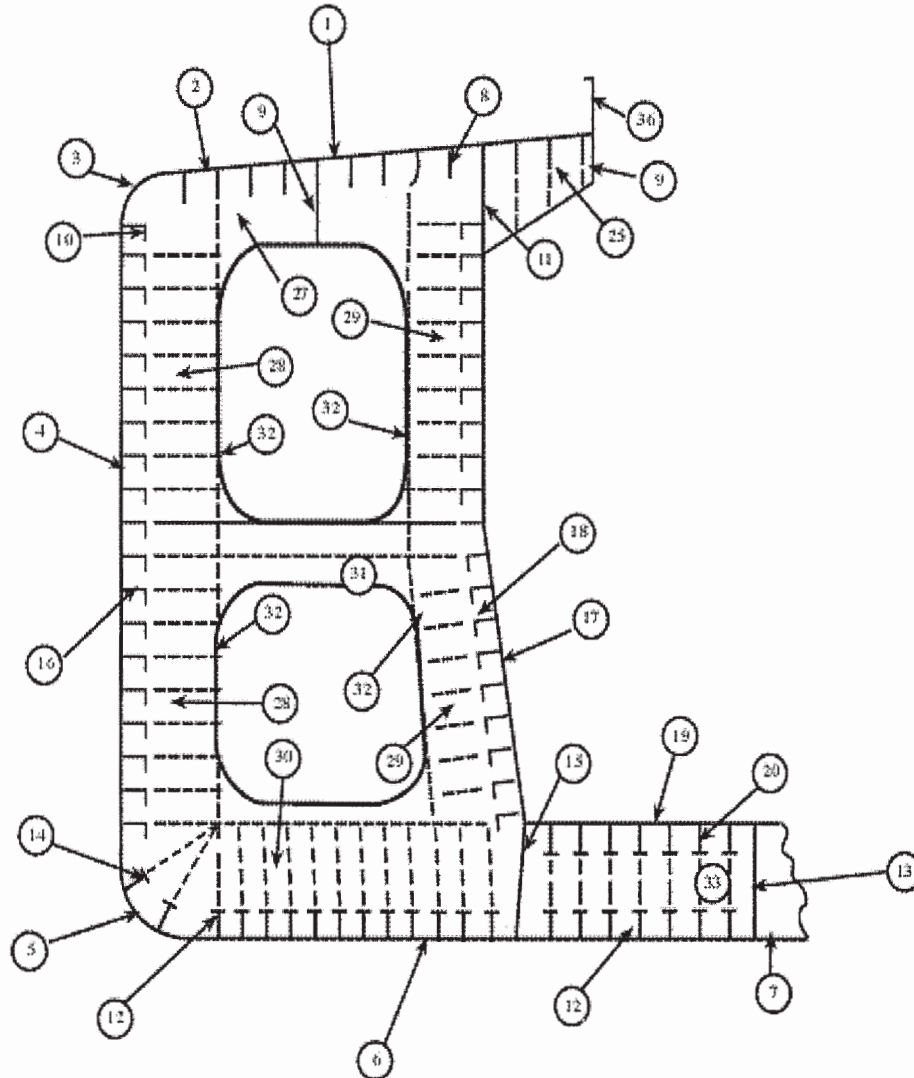
Ore carriers

Thickness measurement and typical transverse section indicating longitudinal and transverse members

Report on TM2-BC (1) and (2)	
1.	Strength deck plating
2.	Stringer plate
3.	Sheerstrake
4.	Side shell plating
5.	Bilge plating
6.	Bottom shell plating
7.	Keel plate

Report on TM6-BC	
36.	Hatch coamings
37.	Deck plating between hatches
38.	Hatch covers

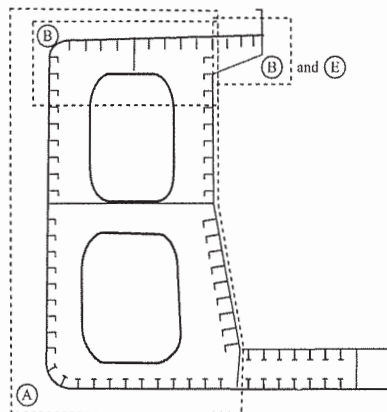
Typical transverse section close-up survey

Ore carriers Thickness measurement and close-up survey requirements

Thickness to be reported on
TM3-T of Annex B and TM4-T of Annex B
as appropriate

Close-up survey
area

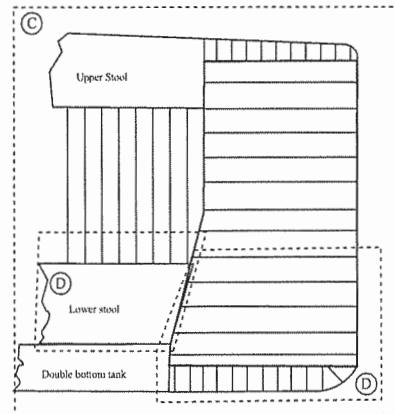
Typical transverse bulkhead

Thickness to be reported on TM5-T of Annex B
